Inspections

Jack Werner, Phd., Lic#255

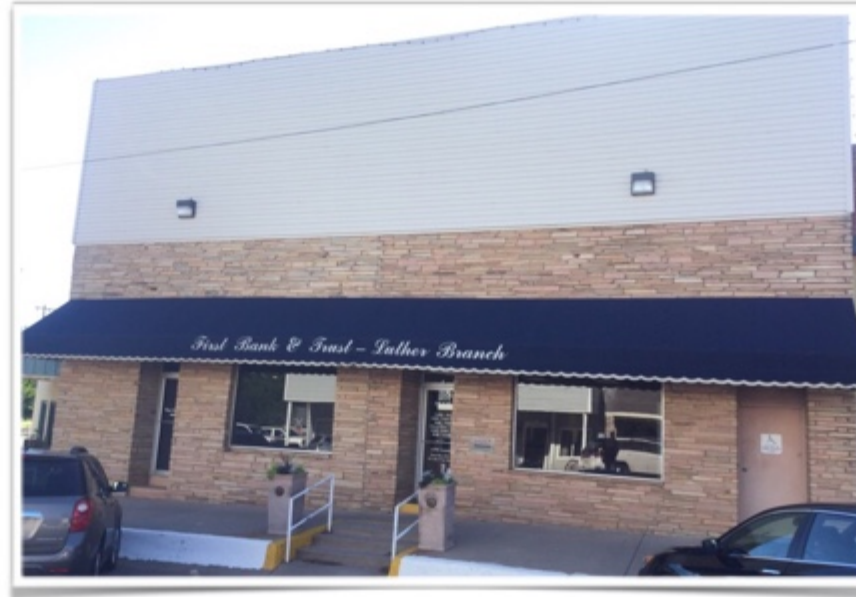
Inspection Property is

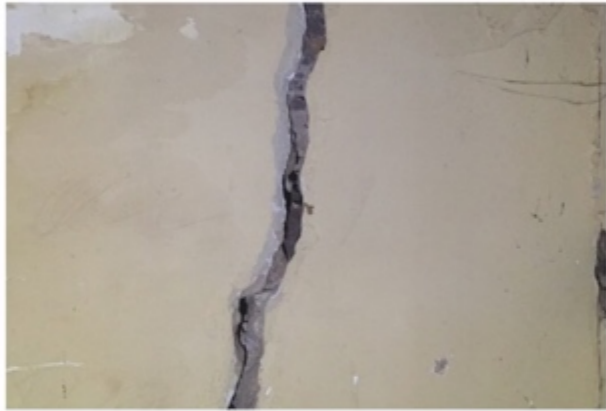
Large crack inside on the N. wall of second floor

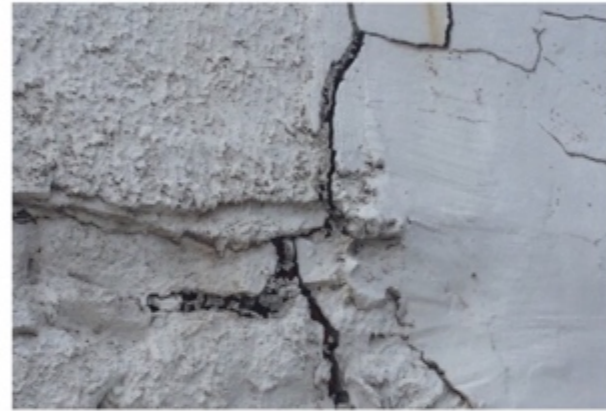
Large crack on exterior N. wall that was sealed & now reopened

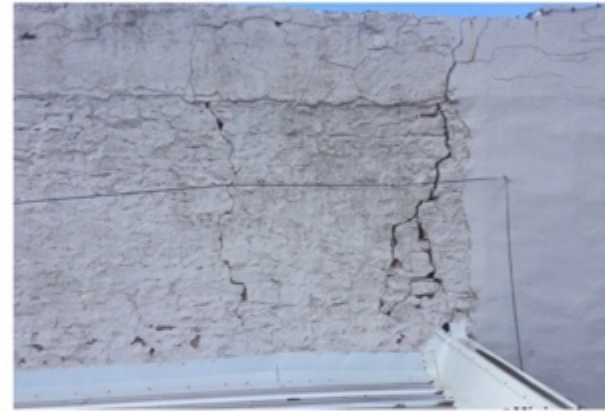
2 of the large cracks on the N. wall

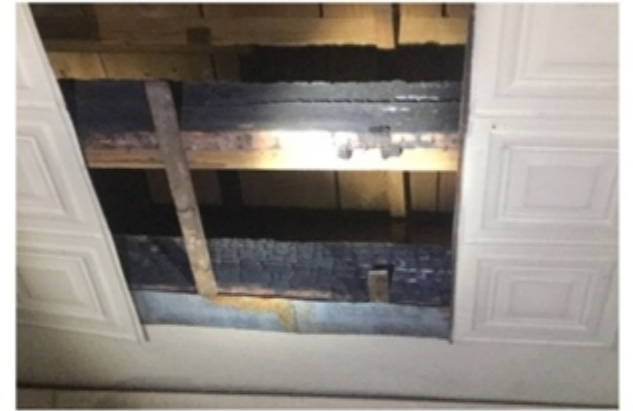
Burnt framing visible at second floor of The N side

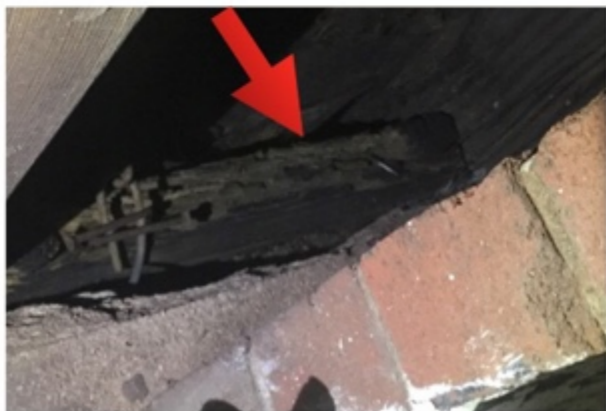
Rotted framing used for siding at front of building

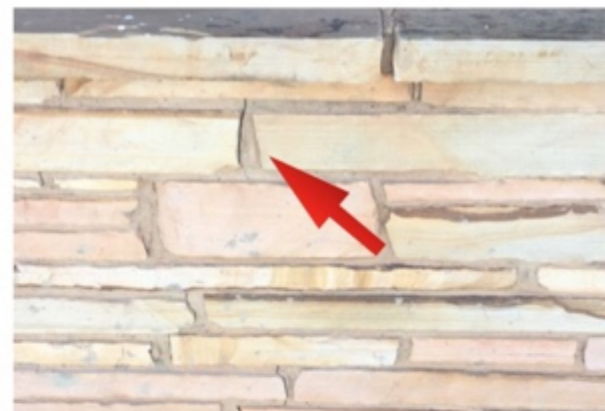
Crack under front window

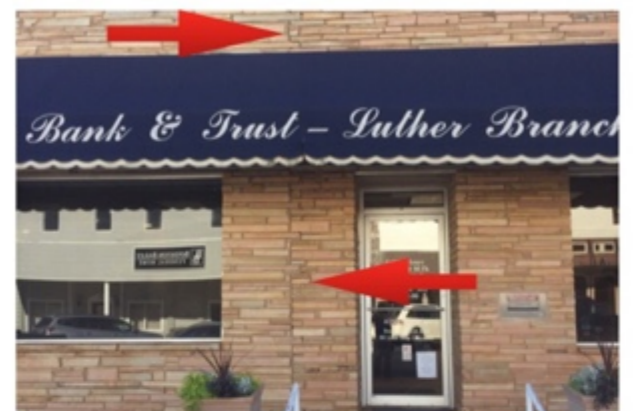
The joint between the N. and S. Sections of the building is cracked all the way up

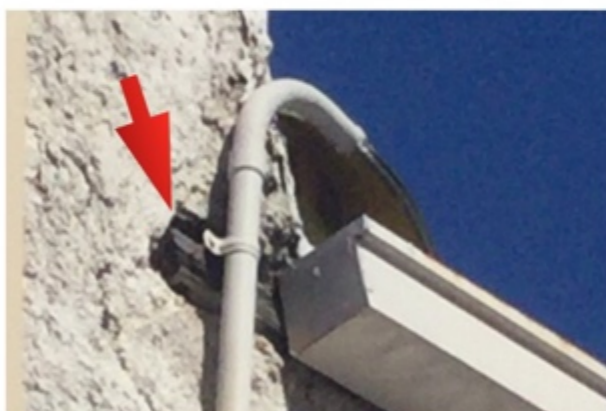
Rotted wood that mast is secured to

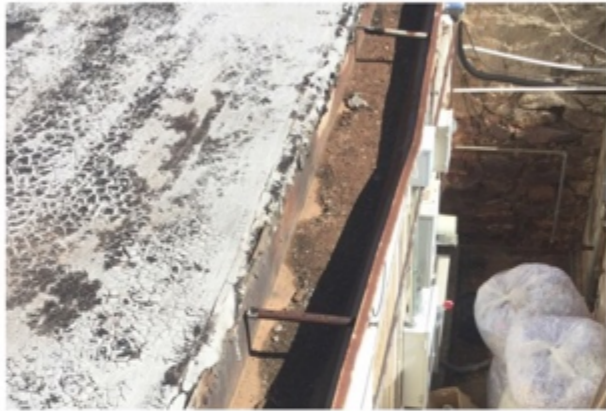
Gutter at back of lower S. Half is damaged and full of debris

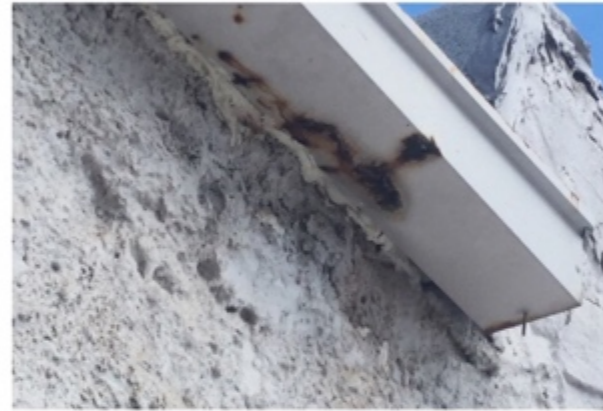
Gutter for upper N. half of the building is rusted through

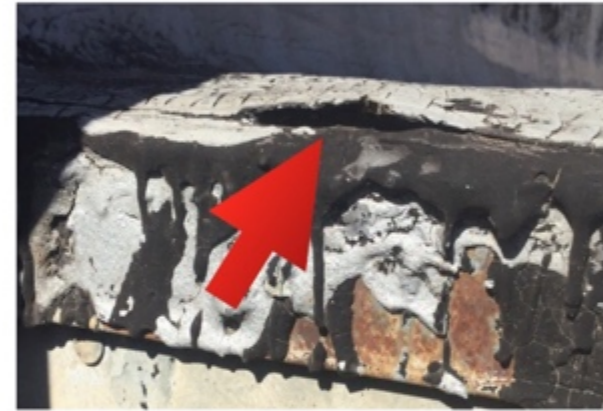
Joint in roofing not fully sealed

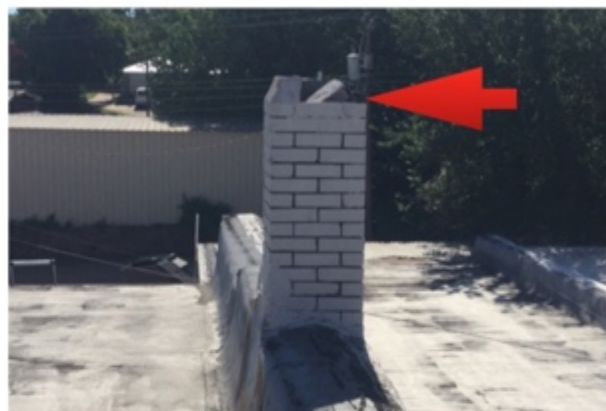
This is the only chimney built above the top of the wall and it has loose bricks

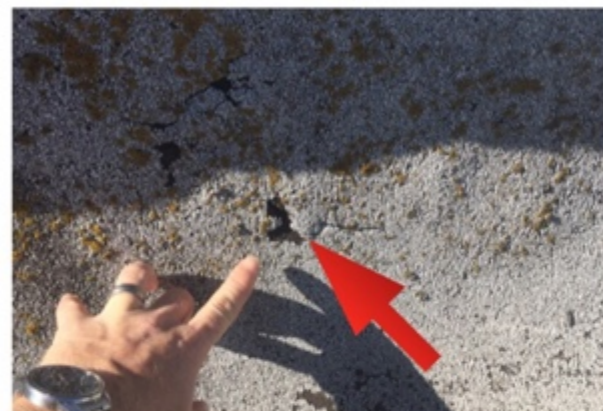
One of the punctures in the roof wall joints

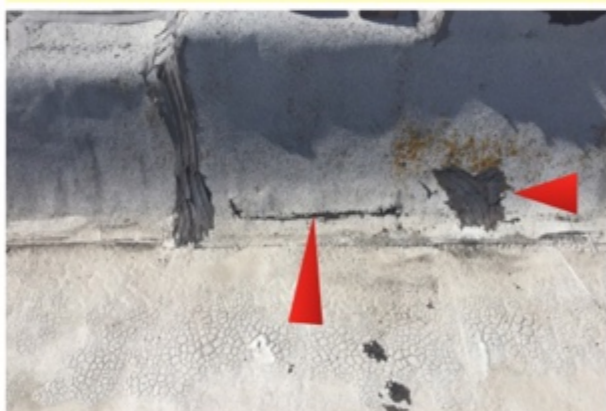
Patch and a torn/cracked section of roofing

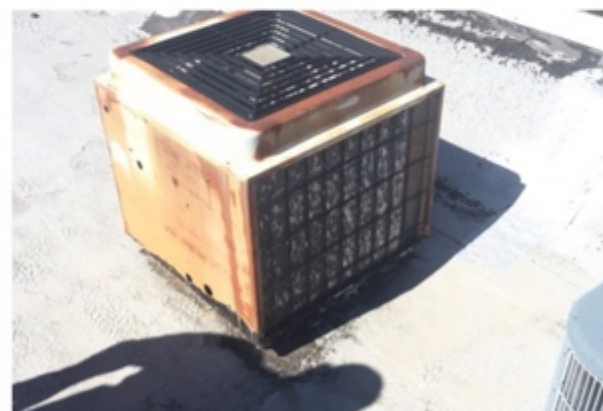
Old unit just left on the roof. It should be removed

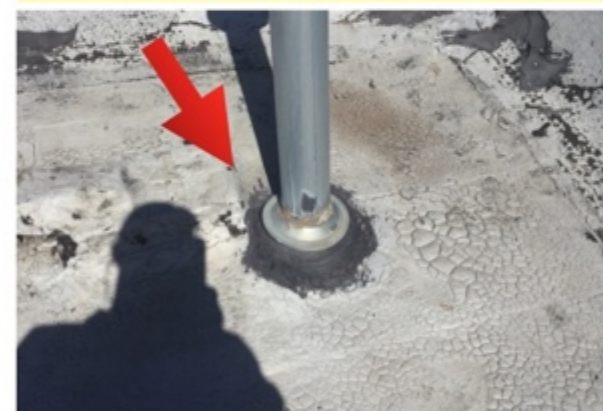
Improper flashing around furnace flue

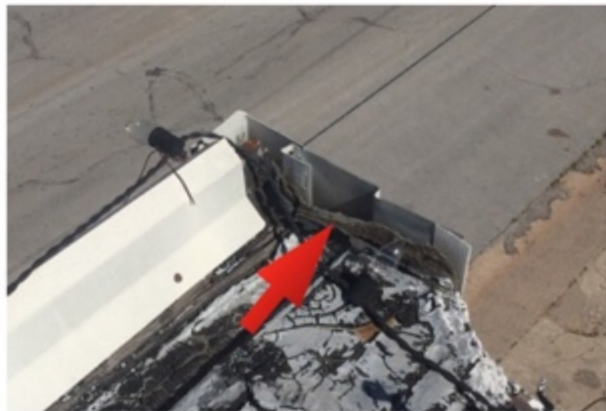
Top of vinyl siding should have a cap over all of it

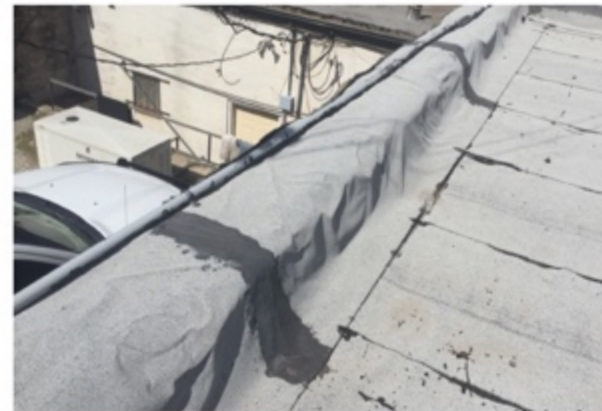
Newer lower N roof. It has several curls and ridges in roll material. It makes it vulnerable for damage and to hail

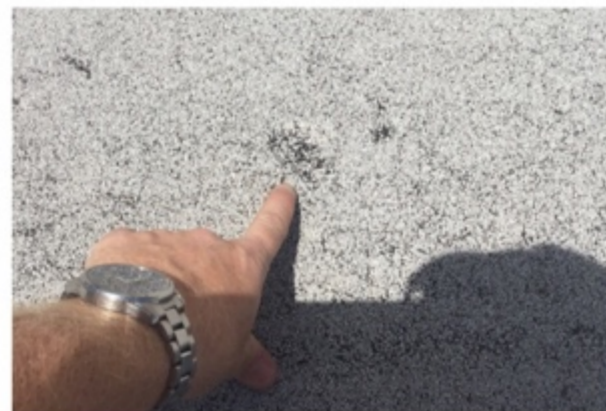
Another possible hail hit

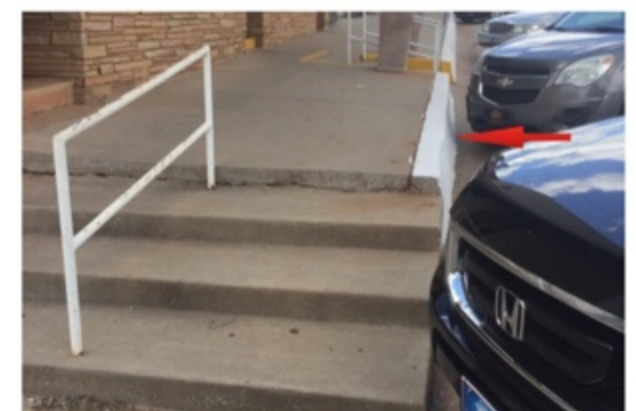
Recommend you install a railing here

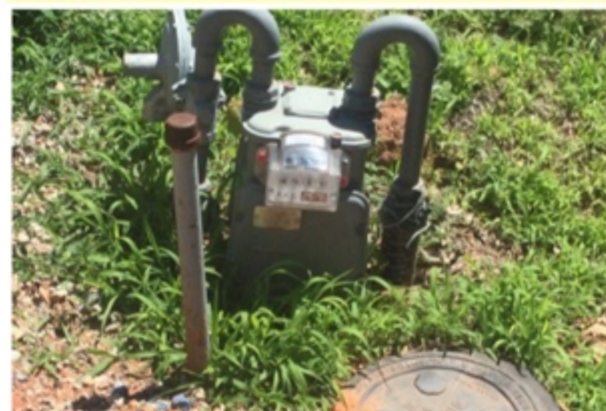
You should make sure with local utility company that this meter is capable to feed large gas line needed for building

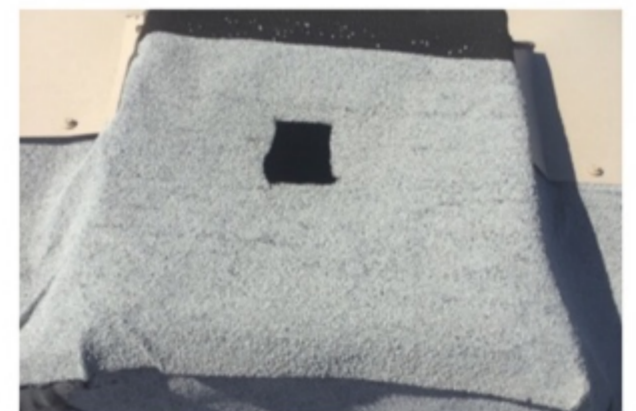
This is the only chimney that is partially covered

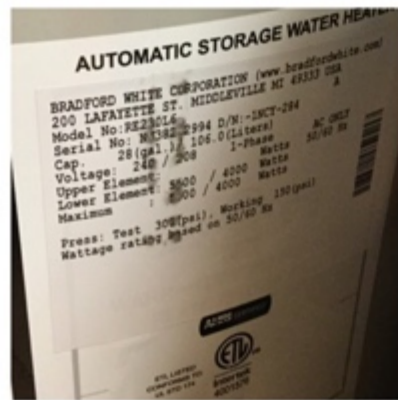
Plumbing Data Plate Breakroom

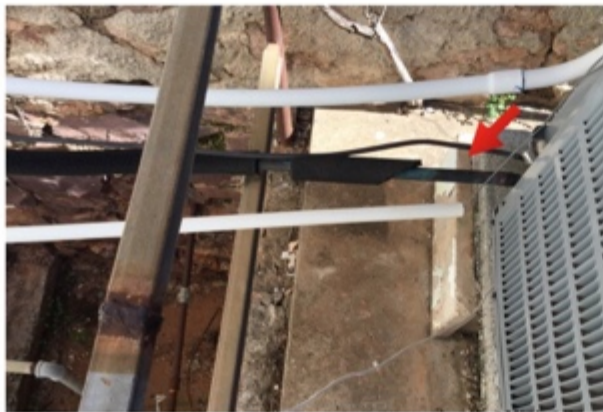
Replace Suction Line Insulation

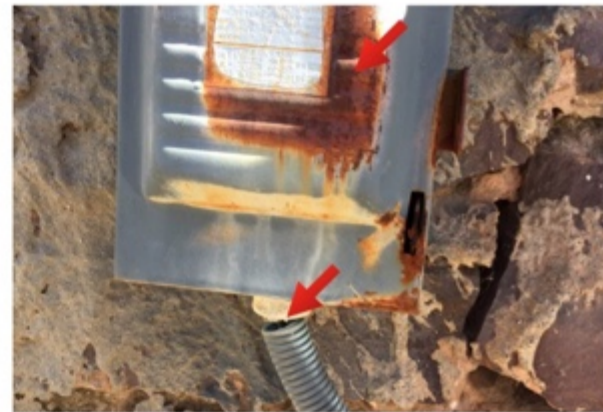
Repair Conduit Break, Paint To Keep From Further Rust

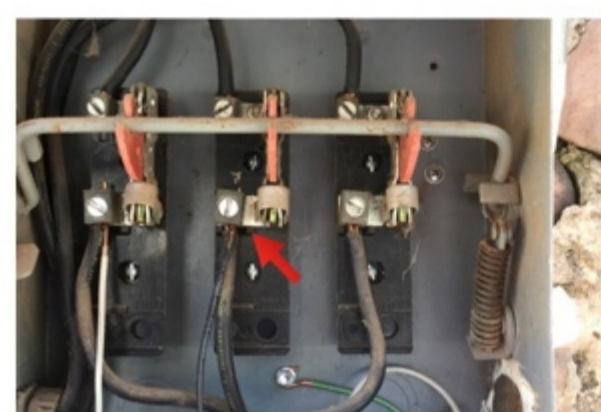
Double Tapped For Mini Split, Improper

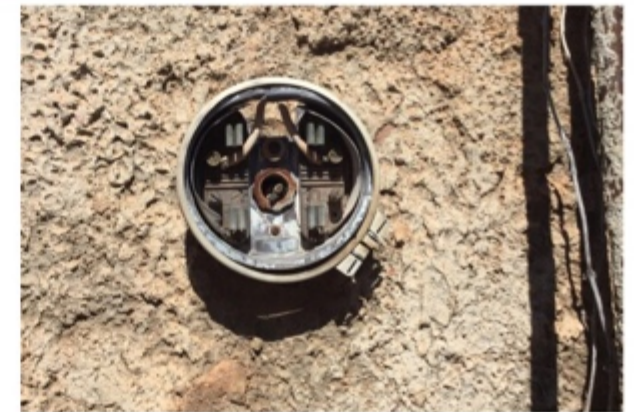
Remove Old Meter Base And Seal Holes

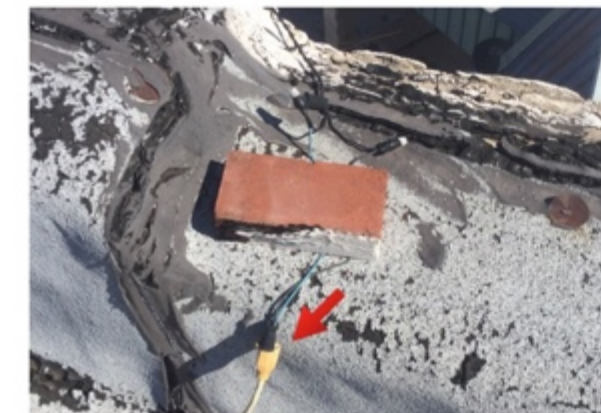
Remove Extension Cord, Damaged

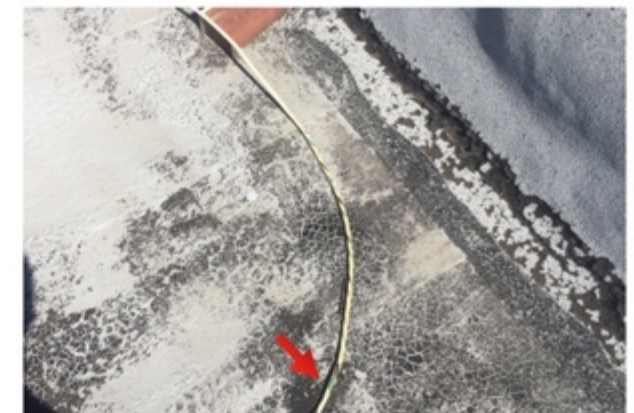
Damaged Section Of Extension Cord

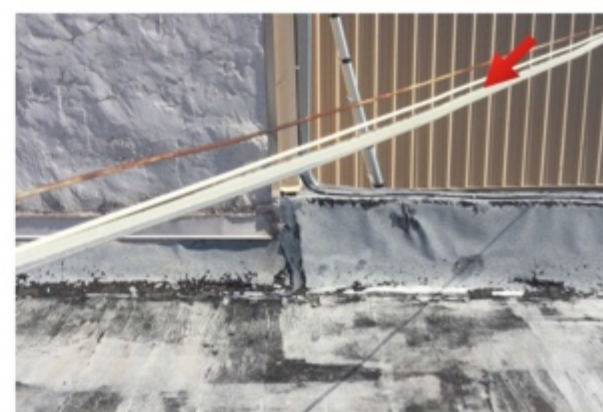
Damaged Romex For Siren Wiring Replace Wiring

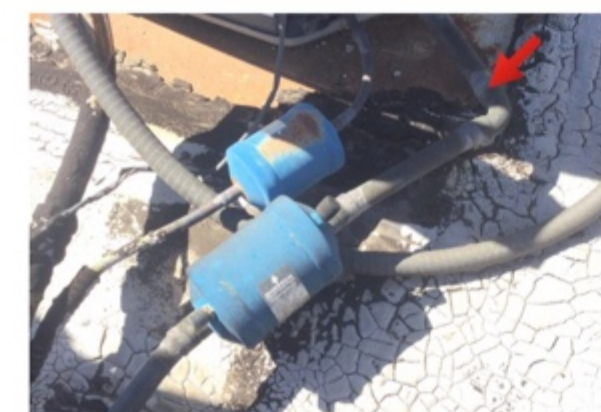
Replace Suction Line Insulation

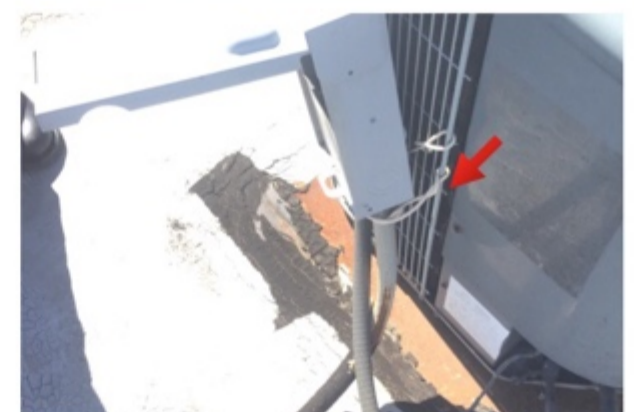
Mount Disconnect Properly

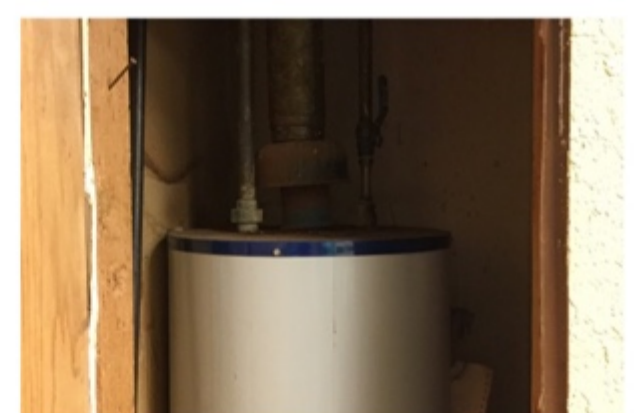
More Copper Gas Pipe

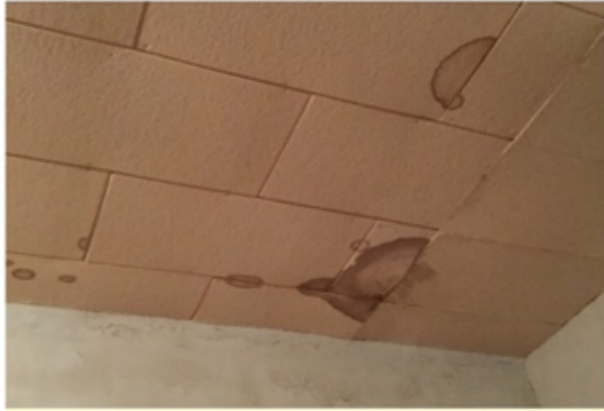
Water Staining In Ceiling Tiles

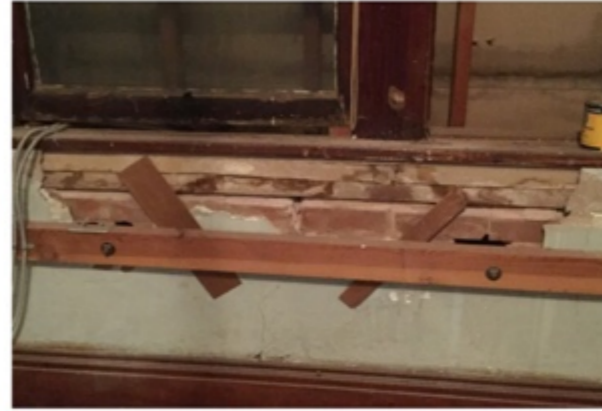
Plaster And Lathe Damaged, Supports For Exterior

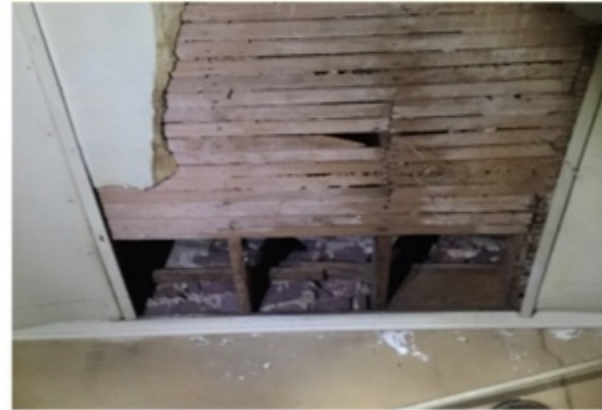
Plaster And Lathe Damage

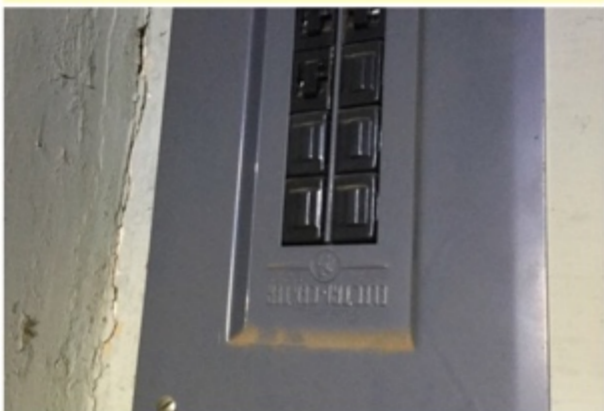
Bull Dog Panel, Remove And Replace

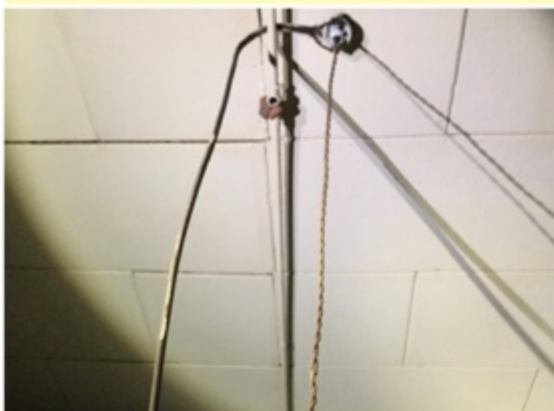
Knob And Tube Wiring, Cut, Remove

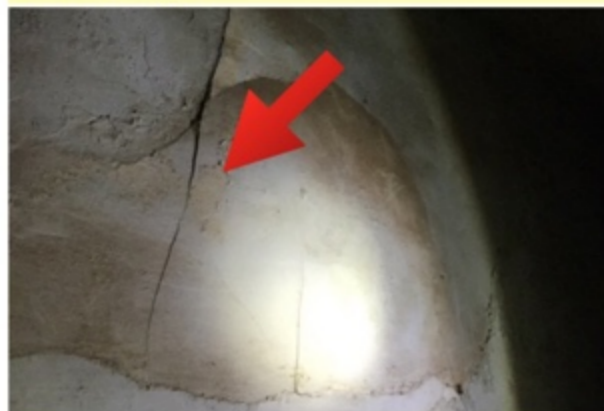
Cracked And Bulging Wall

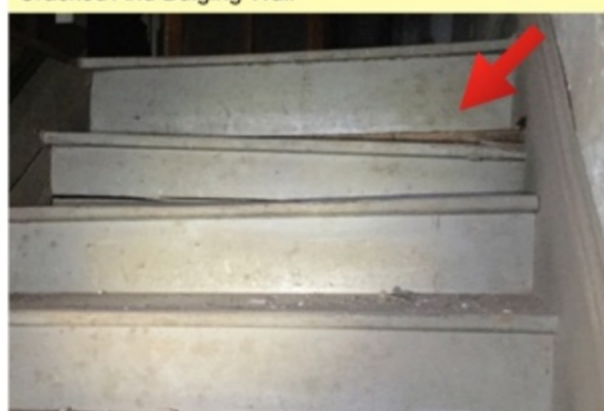
2 Stairs Are Damaged At Top

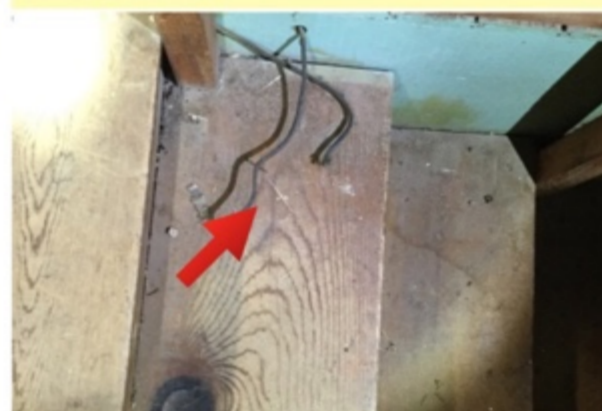
Abandoned Wires At The Stairs

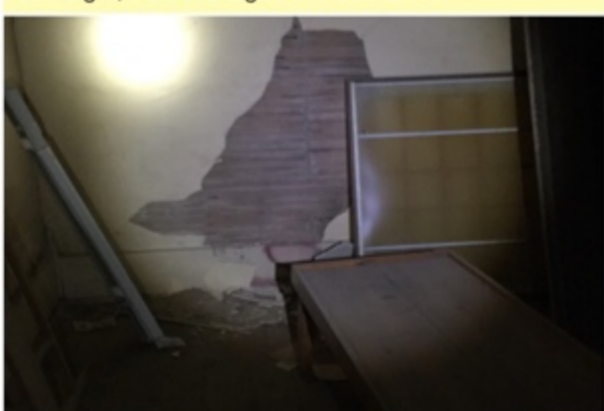
Abandoned Wires Through Ceiling

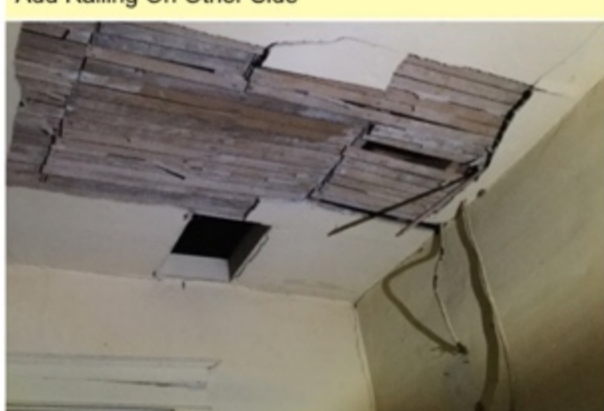
Ceiling Plaster And Lathe Damage

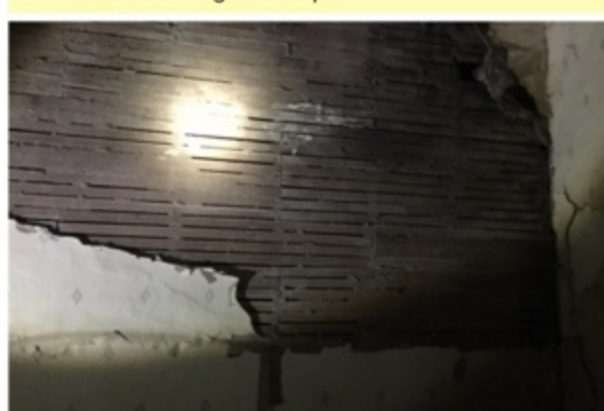
Plaster And Lathe Damage

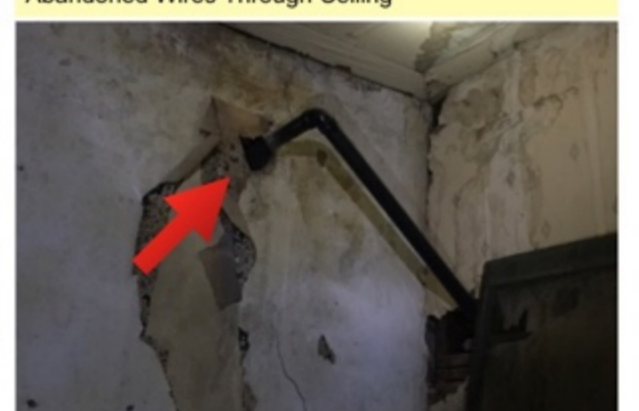
Plumbing Vent Not Venting To Exterior

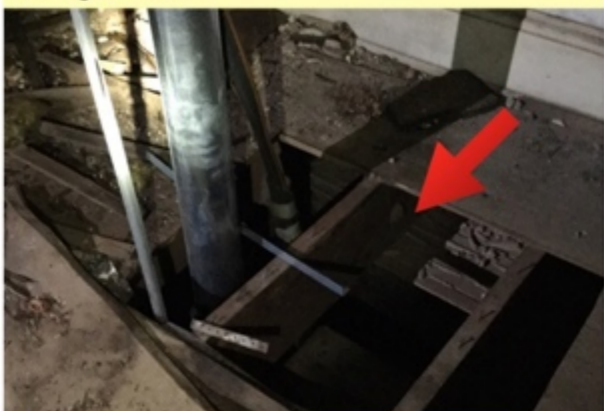
Floor Repairs Needed And Flue Enclosed If Used

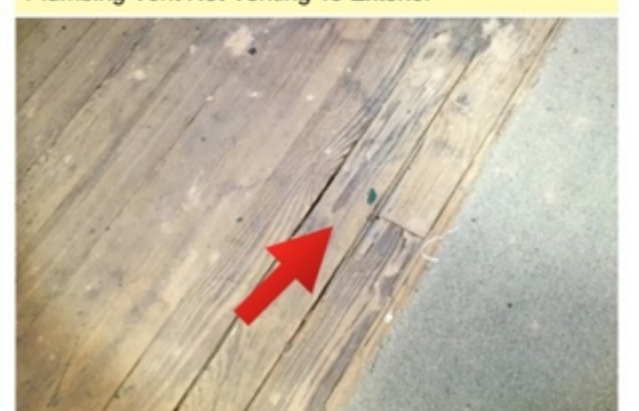
Floors Are Soft In Spots

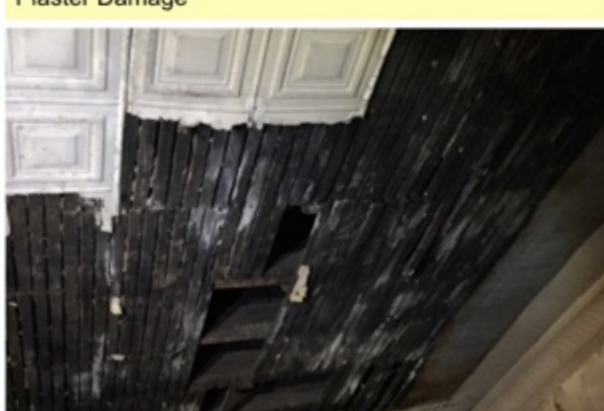
Fire Damaged Ceiling

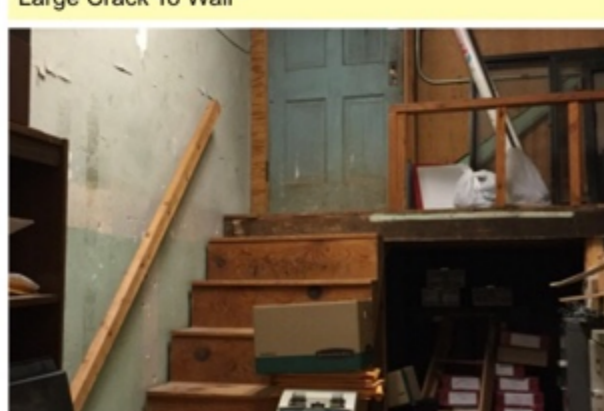
Add Railing To Side, Better If Door Opened Inward
